# Access Compliance Report Public Rights-of-Way (Curb Ramps)

Main Street: MEADOWOOD Cross Street: GREENVALE Location: W

ADA ID: RPRK211018150250 Ramp Type: Type 1 - Perpendicular Diagonal Initial Pass/Fail: Pass Overall Compliance: No Severity Score: 26

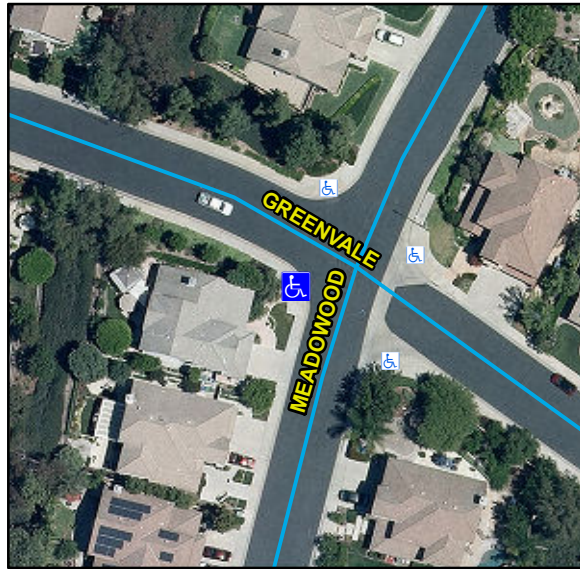
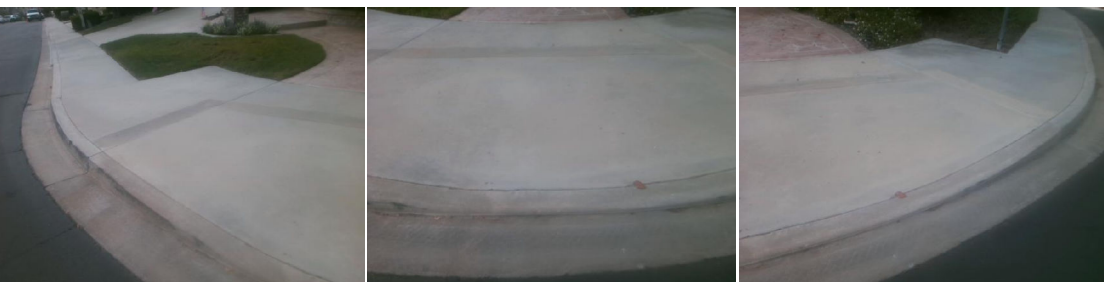
| Compliance | Description | Data | Compliance | Description | Data |
|---|---|---|---|---|---|
| No | Landing Run Slope (%) | 2.2 | N/A | Flare Traversable RT | Yes |
| Yes | Landing Cross Slope (%) | 1.6 | No | DWS Provided | No |
| No | Gutter Lip Height (in) | 0.5 | | Road Run Slope (%) | 0.2 |
| No | Gutter Run Slope (%) | 13 | | Road Cross Slope (%) | 5.4 |

Remove & Replace Curb Ramp With Two New Directional Ramps or Equivalent. Remove & Replace Gutter.
