# Access Compliance Report Public Rights-of-Way (Curb Ramps)

Main Street: GREENVALE Cross Street: MEADOWOOD Location: S

ADA ID: RPRK211018150547 Ramp Type: Type 1 - Perpendicular Diagonal Initial Pass/Fail: Fail Overall Compliance: No Severity Score: 45

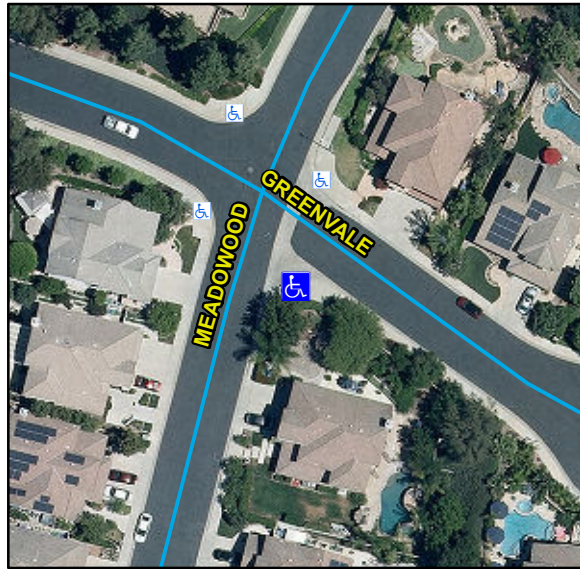
| Compliance | Description | Data | Compliance | Description | Data |
|---|---|---|---|---|---|
| No | Ramp Run Slope (%) | 11.7 | N/A | Flare Slope LT (%) | N/A |
| No | Ramp Cross Slope (%) | 10.8 | N/A | Flare Traversable LT | N/A |
| No | Gutter Lip Height (in) | 0.25 | | Road Run Slope (%) | 10.4 |

**Remove & Replace Curb Ramp With Two New Directional Ramps or Equivalent.**
