# Access Compliance Report Public Rights-of-Way (Curb Ramps)

Main Street: MEADOWOOD Cross Street: CASTLETREE Location: SE

ADA ID: RPRK211018150926 Ramp Type: Type 1 - Perpendicular Diagonal Initial Pass/Fail: Fail Overall Compliance: No Severity Score: 30

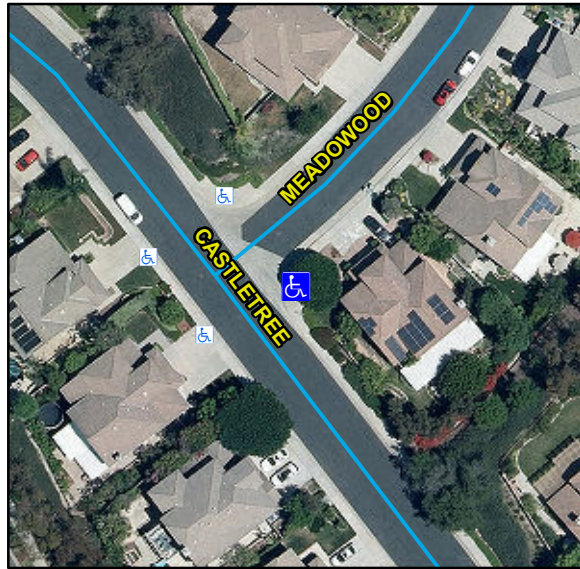
| Compliance | Description | Data | Compliance | Description | Data |
|---|---|---|---|---|---|
| No | Ramp Run Slope (%) | 9.1 | N/A | Flare Slope LT (%) | N/A |
| No | Ramp Cross Slope (%) | 5.6 | N/A | Flare Traversable LT | N/A |
| No | Gutter Lip Height (in) | 0.25 | | Road Run Slope (%) | 6.2 |

Remove & Replace Curb Ramp With Two New Directional Ramps or Equivalent.

R304.2.2, R204.3, R304.5.3, R302.7.2, STD 1115
