# Access Compliance Report Public Rights-of-Way (Curb Ramps)

Main Street: CASTLETREE Cross Street: MEADOWOOD Location: NE

ADA ID: RPRK211018151212 Ramp Type: Type 1 - Perpendicular Diagonal Initial Pass/Fail: Fail Overall Compliance: No Severity Score: 30

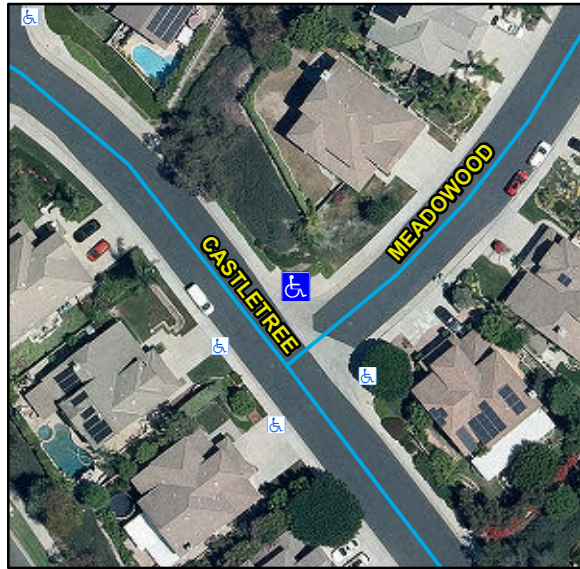
| Compliance | Description | Data | Compliance | Description | Data |
|---|---|---|---|---|---|
| No | Ramp Cross Slope (%) | 14.3 | N/A | Flare Traversable LT | N/A |
| No | Gutter Lip Height (in) | 0.25 | | Road Run Slope (%) | 9.7 |

Remove & Replace Curb Ramp With Two New Directional Ramps or Equivalent.

R304.2.2, R204.3, R304.5.3, R302.7.2, STD 1115
