# Access Compliance Report Public Rights-of-Way (Curb Ramps)

Main Street: CASTLETREE Cross Street: CLOVERDALE Location: NE

ADA ID: RPRK211018151349 Ramp Type: Type 1 - Perpendicular Diagonal Initial Pass/Fail: Fail Overall Compliance: No Severity Score: 45

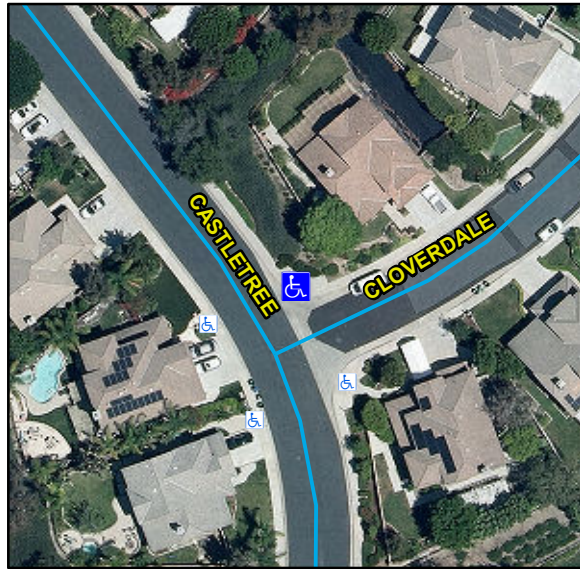
| Compliance | Description | Data | Compliance | Description | Data |
|---|---|---|---|---|---|
| No | Ramp Run Slope (%) | 9.6 | N/A | Flare Slope LT (%) | N/A |
| No | Ramp Cross Slope (%) | 7.1 | N/A | Flare Traversable LT | N/A |
| No | Gutter Lip Height (in) | 0.25 | | Road Run Slope (%) | 5.5 |

**Remove & Replace Curb Ramp With Two New Directional Ramps or Equivalent. Grind Gutter Lip.**
