# Access Compliance Report Public Rights-of-Way (Curb Ramps)

Main Street: CLOVERDALE Cross Street: CASTLETREE Location: SE

ADA ID: RPRK211018151707 Ramp Type: Type 1 - Perpendicular Diagonal Initial Pass/Fail: Fail Overall Compliance: No Severity Score: 30

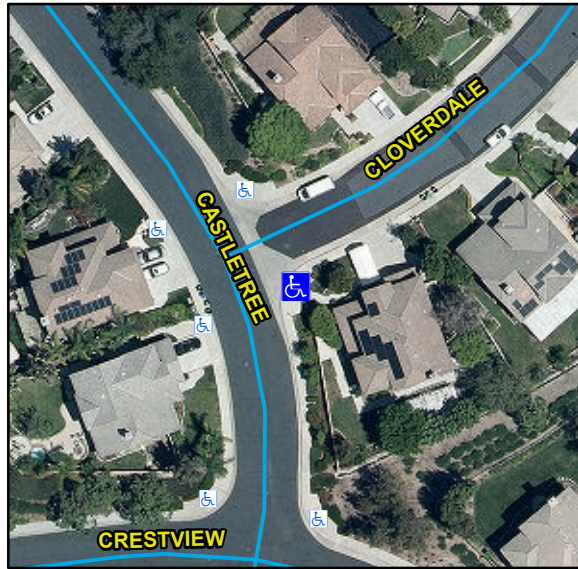
| Compliance | Description | Data | Compliance | Description | Data |
|---|---|---|---|---|---|
| No | Ramp Run Slope (%) | 13.7 | N/A | Flare Slope LT (%) | N/A |
| No | Gutter Lip Height (in) | 0.25 | | Road Run Slope (%) | 1.7 |

Remove & Replace Curb Ramp With Two New Directional Ramps or Equivalent. Grind Gutter Lip.

R204.3, R304.2.2, R302.7.2, STD 1115
