# Access Compliance Report Public Rights-of-Way (Curb Ramps)

Main Street: CASTLETREE Cross Street: CRESTVIEW Location: E

ADA ID: RPRK211018151909 Ramp Type: Type 1 - Perpendicular Diagonal Initial Pass/Fail: Fail Overall Compliance: No Severity Score: 45

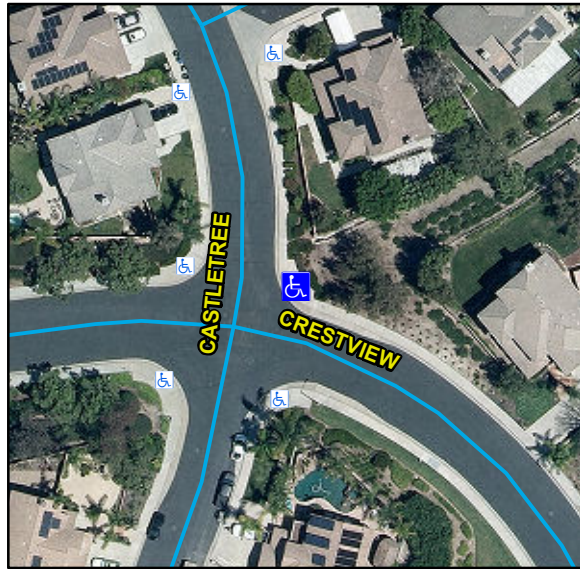
| Compliance | Description | Data | Compliance | Description | Data |
|---|---|---|---|---|---|
| No | Ramp Run Slope (%) | 8.4 | N/A | Flare Slope LT (%) | N/A |
| No | Ramp Cross Slope (%) | 8.1 | N/A | Flare Traversable LT | N/A |
| No | Gutter Lip Height (in) | 0.25 | | Road Run Slope (%) | 7.3 |

Remove & Replace Curb Ramp With Two New Directional Ramps or Equivalent.
