# Access Compliance Report Public Rights-of-Way (Curb Ramps)

Main Street: CASTLETREE Cross Street: CRESTVIEW Location: W

ADA ID: RPRK211018152324 Ramp Type: Type 1 - Perpendicular Diagonal Initial Pass/Fail: Fail Overall Compliance: No Severity Score: 30

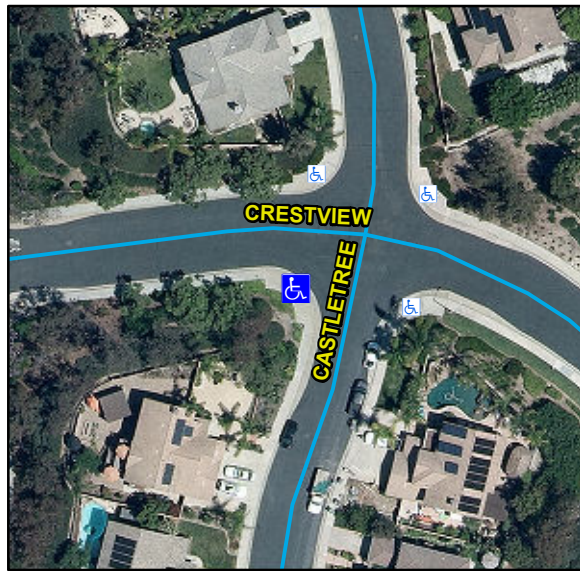
| Compliance | Description | Data | Compliance | Description | Data |
|---|---|---|---|---|---|
| No | Ramp Cross Slope (%) | 11.5 | N/A | Flare Traversable LT | N/A |
| No | Gutter Lip Height (in) | 0.25 | | Road Run Slope (%) | 8.5 |

**Remove & Replace Curb Ramp With Two New Directional Ramps or Equivalent. Grind Gutter Lip.**

**R204.3, R304.5.3, R302.7.2, STD 1115**
