# Access Compliance Report Public Rights-of-Way (Curb Ramps)

Main Street: CRESTVIEW Cross Street: CASTLETREE Location: N

ADA ID: RPRK211018152457 Ramp Type: Type 1 - Perpendicular Diagonal Initial Pass/Fail: Fail Overall Compliance: No Severity Score: 30

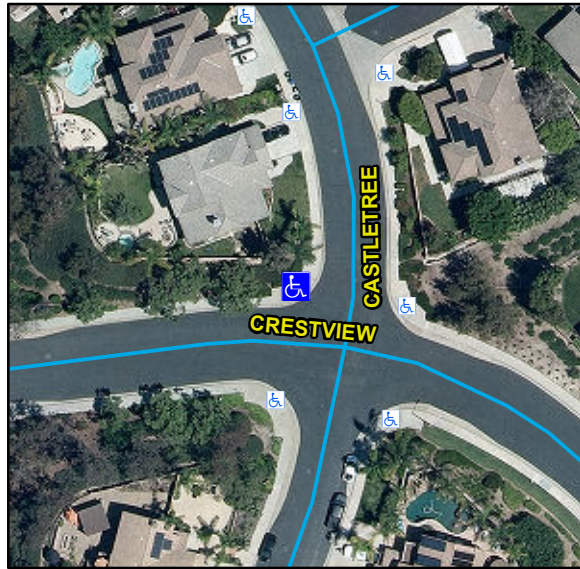
| Compliance | Description | Data | Compliance | Description | Data |
|---|---|---|---|---|---|
| No | Ramp Run Slope (%) | 8.6 | N/A | Flare Slope LT (%) | N/A |
| No | Ramp Cross Slope (%) | 5.9 | N/A | Flare Traversable LT | N/A |
| No | Gutter Lip Height (in) | 0.25 | | Road Run Slope (%) | 5.6 |

Remove & Replace Curb Ramp With Two New Directional Ramps or Equivalent. Grind Gutter Lip.
