# Access Compliance Report Public Rights-of-Way (Curb Ramps)

Main Street: MEANDERING\_TRAIL Cross Street: CRESTVIEW Location: NE

ADA ID: RPRK211018152721 Ramp Type: Type 1 - Perpendicular Diagonal Initial Pass/Fail: Fail Overall Compliance: No Severity Score: 30

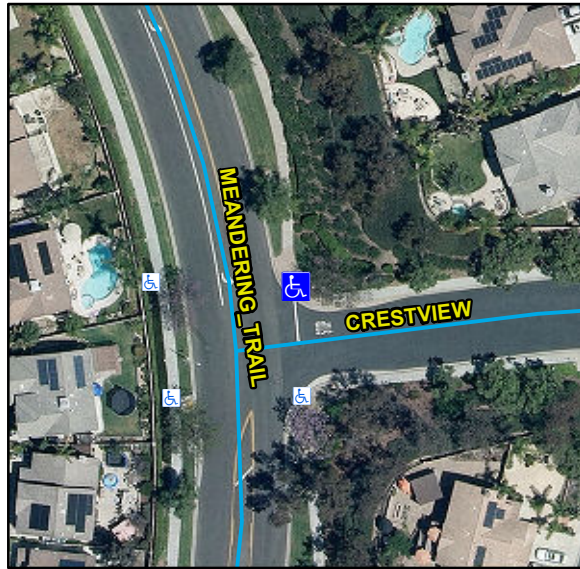
| Compliance | Description | Data | Compliance | Description | Data |
|---|---|---|---|---|---|
| No | Ramp Run Slope (%) | 10.2 | N/A | Flare Slope LT (%) | N/A |
| No | Ramp Cross Slope (%) | 6.3 | N/A | Flare Traversable LT | N/A |

Remove & Replace Curb Ramp With Two New Directional Ramps or Equivalent.
