# Access Compliance Report Public Rights-of-Way (Curb Ramps)

Main Street: CRESTVIEW Cross Street: MEANDERING\_TRAIL Location: SE

ADA ID: RPRK211018152910 Ramp Type: Type 1 - Perpendicular Diagonal Initial Pass/Fail: Pass Overall Compliance: No Severity Score: 0

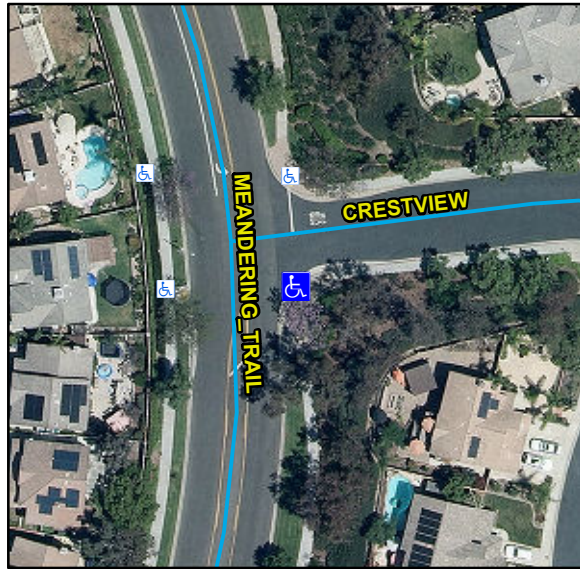
| Compliance | Description | Data | Compliance | Description | Data |
|---|---|---|---|---|---|
| Yes | Gutter Ponding | No | No | Curb Slope | 9.1 |

Remove & Replace Curb Slope.

R304.2.2, STD 1115
