# Access Compliance Report Public Rights-of-Way (Curb Ramps)

| Main Street: MEANDERING TRAIL | | Cross Street: CASTLETREE | | Location: | SW |
| ADA ID: RPRK211018153215 | Ramp Type: Type 1 - Perpendicular | Initial Pass/Fail: Fail | Overall Compliance: No | Severity Score: | 15 |

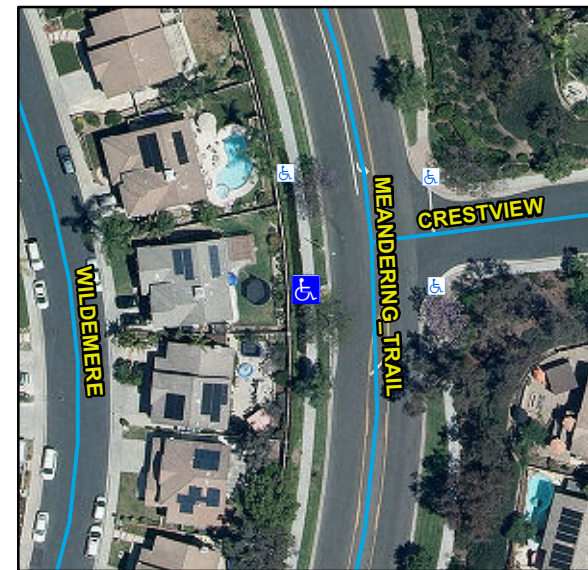
R304.2.2, R204.3, STD 1115

| Compliance | Description | Data | Compliance | Description | Data |
|---|---|---|---|---|---|
| No | Ramp Run Slope (%) | 11.8 | N/A | Flare Slope LT (%) | N/A |

Remove & Replace Entire Ramp.

Total Cost: \$ 3080
