# Access Compliance Report Public Rights-of-Way (Curb Ramps)

Main Street: MEANDERING\_TRAIL Cross Street: WOODSONG Location: SW

ADA ID: RPRK211018153530 Ramp Type: Type 1 - Perpendicular Diagonal Initial Pass/Fail: Fail Overall Compliance: No Severity Score: 30

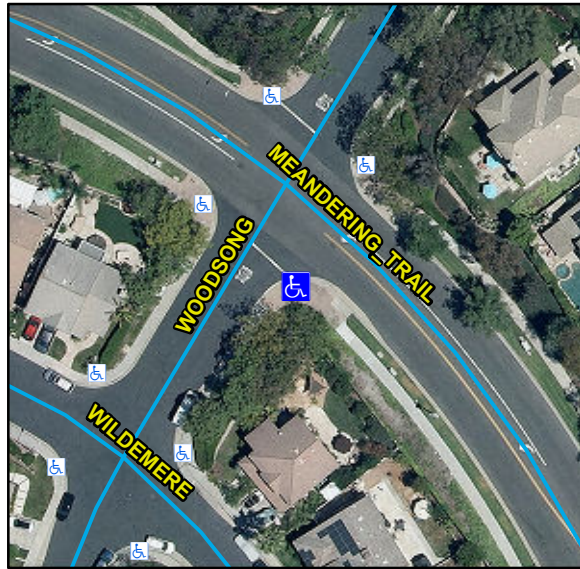
| Compliance | Description | Data | Compliance | Description | Data |
|---|---|---|---|---|---|
| No | Ramp Run Slope (%) | 11.8 | N/A | Flare Slope LT (%) | N/A |
| No | Ramp Cross Slope (%) | 6.5 | N/A | Flare Traversable LT | N/A |

**Remove & Replace Curb Ramp With Two New Directional Ramps or Equivalent.**

**R304.2.2, R204.3, R304.5.3, STD 1115**
