# Access Compliance Report Public Rights-of-Way (Curb Ramps)

Main Street: WILDEMERE Cross Street: WOODSONG Location: N

ADA ID: RPRK211018153906 Ramp Type: Type 4 - Parallel Initial Pass/Fail: Pass Overall Compliance: No Severity Score: 26

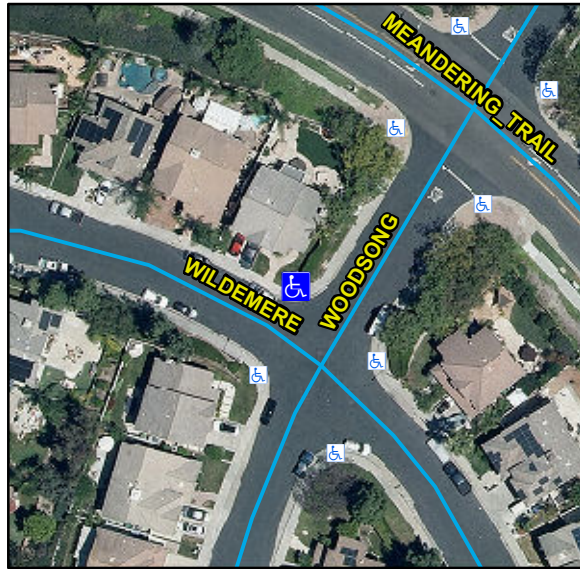
| Compliance | Description | Data | Compliance | Description | Data |
|---|---|---|---|---|---|
| No | Ramp Cross Slope LT (%) | 2.4 | Yes | Ramp Cross Slope RT (%) | 2 |
| No | Landing Width (in) | N/A | N/A | DWS Length (in) | N/A |
| No | Landing Run Slope (%) | N/A | N/A | DWS Full Width | N/A |
| No | Landing Cross Slope (%) | N/A | | DWS Offset Type | N/A |
| No | Gutter Lip Height (in) | 0.25 | | Road Run Slope (%) | 1.8 |
| No | Gutter Run Slope (%) | 5.8 | | Road Cross Slope (%) | 5.8 |
| No | Gutter Cross Slope (%) | 2.7 | No | Perpendicular Joint Present | No |

Remove & Replace Curb Ramp With Two New Directional Ramps or Equivalent. Remove & Replace Gutter.
