# Access Compliance Report Public Rights-of-Way (Curb Ramps)

Main Street: WILDEMERE Cross Street: WOODSONG Location: S

ADA ID: RPRK211018154402 Ramp Type: Type 1 - Perpendicular Diagonal Initial Pass/Fail: Pass Overall Compliance: No Severity Score: 29

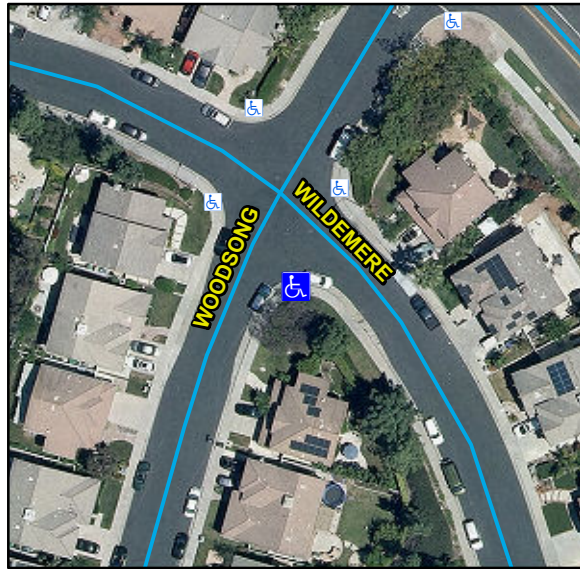
| Compliance | Description | Data | Compliance | Description | Data |
|---|---|---|---|---|---|
| Yes | Ramp Run Slope (%) | 7.8 | No | Flare Slope LT (%) | 11.1 |
| No | Ramp Cross Slope (%) | 2.5 | N/A | Flare Traversable LT | Yes |
| No | Landing Width (in) | N/A | No | Flare Slope RT (%) | 10.2 |
| No | Landing Cross Slope (%) | N/A | No | DWS Provided | No |
| No | Gutter Lip Height (in) | 0.25 | | Road Run Slope (%) | 1.4 |
| No | Gutter Run Slope (%) | 6.8 | | Road Cross Slope (%) | 1.5 |

Remove & Replace Curb Ramp With Two New Directional Ramps or Equivalent. Remove & Replace Gutter.
