# Access Compliance Report Public Rights-of-Way (Curb Ramps)

Main Street: WOODSONG Cross Street: WILDEMERE Location: E

ADA ID: RPRK211018154607 Ramp Type: Type 1 - Perpendicular Diagonal Initial Pass/Fail: Fail Overall Compliance: No Severity Score: 2

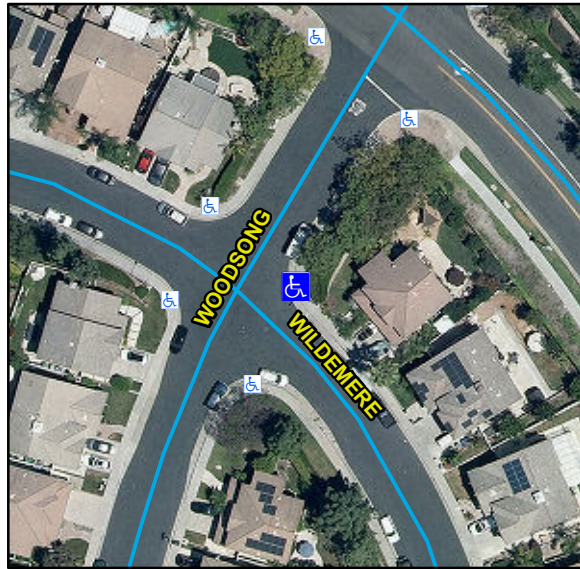
| Compliance | Description | Data | Compliance | Description | Data |
|---|---|---|---|---|---|
| No | Ramp Cross Slope (%) | 3.4 | N/A | Flare Traversable LT | N/A |
| No | Gutter Lip Height (in) | 0.25 | | Road Run Slope (%) | 3.3 |

**Remove & Replace Curb Ramp With Two New Directional Ramps or Equivalent.**

**R304.2.2, R204.3, R304.5.3, R302.7.2, STD 1115**
