# Access Compliance Report Public Rights-of-Way (Curb Ramps)

Main Street: WOODSONG Cross Street: MEANDERING\_TRAIL Location: E

ADA ID: RPRK211018155133 Ramp Type: Type 4 - Parallel Initial Pass/Fail: Fail Overall Compliance: No Severity Score: 30

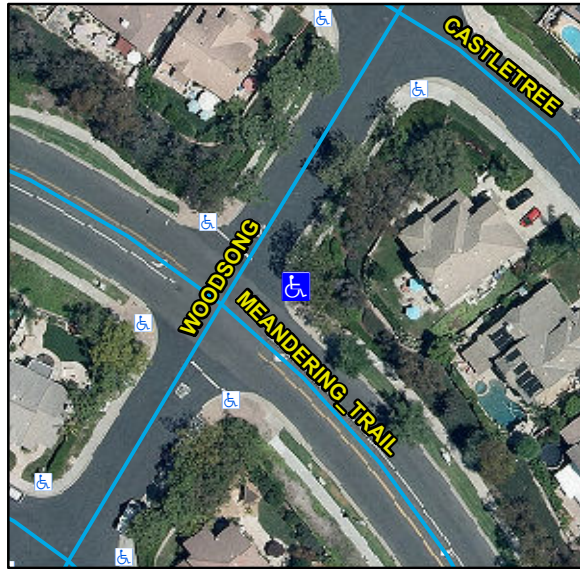
| Compliance | Description | Data | Compliance | Description | Data |
|---|---|---|---|---|---|
| Yes | Ramp Run Slope LT (%) | 3.1 | No | Ramp Run Slope RT (%) | 8.9 |
| No | Ramp Cross Slope LT (%) | 5.6 | No | Ramp Cross Slope RT (%) | 5.1 |

Remove & Replace Curb Ramp With Two New Directional Ramps or Equivalent.
