# Access Compliance Report Public Rights-of-Way (Curb Ramps)

| Main Street: MEANDERING_TRAIL | | Cross Street: WOODSONG | | Location: | N |
| ADA ID: RPRK211018155415 | Ramp Type: Type 4 - Parallel | Initial Pass/Fail: Fail | Overall Compliance: No | Severity Score: | 45 |

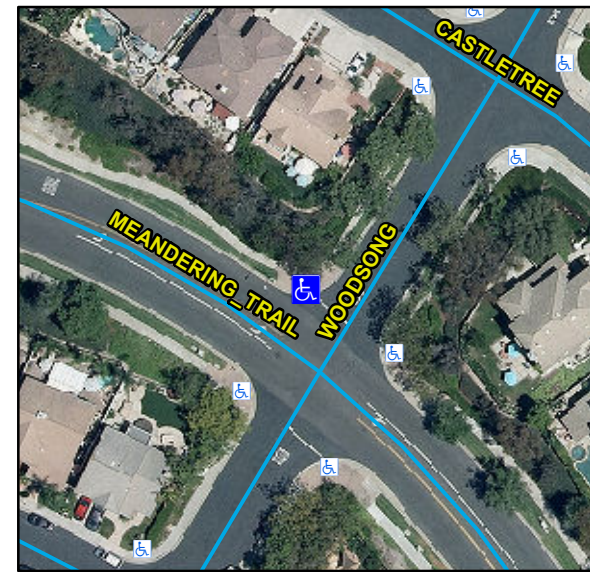
| Compliance | Description | Data | Compliance | Description | Data |
|---|---|---|---|---|---|
| Yes | Ramp Run Slope LT (%) | 2.1 | No | Ramp Run Slope RT (%) | 16.9 |
| No | Ramp Cross Slope LT (%) | 3.6 | No | Ramp Cross Slope RT (%) | 5.1 |

**Remove & Replace Curb Ramp With Two New Directional Ramps or Equivalent.**

**R204.3, R304.5.3, R304.3.2, STD 1115**
