# Access Compliance Report Public Rights-of-Way (Curb Ramps)

Main Street: ANTONIO\_PKWY Cross Street: MEANDERING\_TRAIL Location: E

ADA ID: RPRK211018160117 Ramp Type: Type 4 - Parallel Initial Pass/Fail: Fail Overall Compliance: No Severity Score: 15

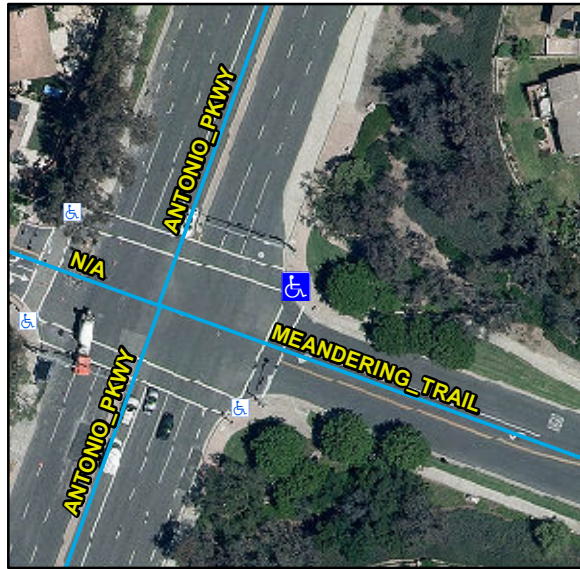
| Compliance | Description | Data | Compliance | Description | Data |
|---|---|---|---|---|---|
| No | Ramp Cross Slope LT (%) | 6.5 | No | Ramp Cross Slope RT (%) | 5 |

**Remove & Replace Curb Ramp With Two New Directional Ramps or Equivalent.**

**R204.3, R304.5.3, STD 1115**
