# Access Compliance Report Public Rights-of-Way (Curb Ramps)

Main Street: MEANDERING\_TRAIL Cross Street: ANTONIO\_PKWY Location: S

ADA ID: RPRK211018160726 Ramp Type: Type 4 - Parallel Initial Pass/Fail: Fail Overall Compliance: No Severity Score: 30

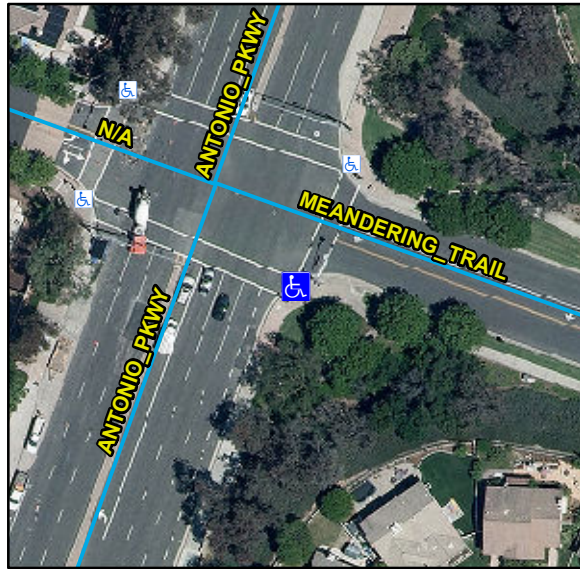
| Compliance | Description | Data | Compliance | Description | Data |
|---|---|---|---|---|---|
| No | Ramp Cross Slope LT (%) | 4.9 | No | Ramp Cross Slope RT (%) | 7.2 |

Remove & Replace Curb Ramp With Two New Directional Ramps or Equivalent.

R204.3, R304.5.3, STD 1115
