# Access Compliance Report Public Rights-of-Way (Curb Ramps)

| Main Street: STARLIGHT_RIDGE | | Cross Street: SUMMIT_CT | | Location: | SE |
| ADA ID: RPRK211018173742 | Ramp Type: Type 4 - Parallel | Initial Pass/Fail: Fail | Overall Compliance: No | Severity Score: | 30 |

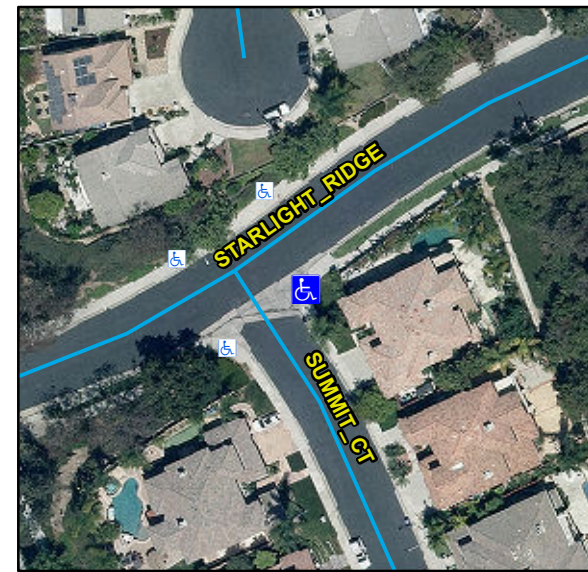
| Compliance | Description | Data | Compliance | Description | Data |
|---|---|---|---|---|---|
| No | Ramp Run Slope LT (%) | 13.5 | Yes | Ramp Run Slope RT (%) | 2.1 |

**Remove & Replace Curb Ramp With Two New Directional Ramps or Equivalent.**

**R204.3, R304.3.2, STD 1115**

Total Cost: \$ 4000
