# Access Compliance Report Public Rights-of-Way (Curb Ramps)

Main Street: SHASTA\_CT Cross Street: STARLIGHT\_RIDGE Location: SW

ADA ID: RPRK211018174231 Ramp Type: Type 1 - Perpendicular Diagonal Initial Pass/Fail: Pass Overall Compliance: No Severity Score: 60

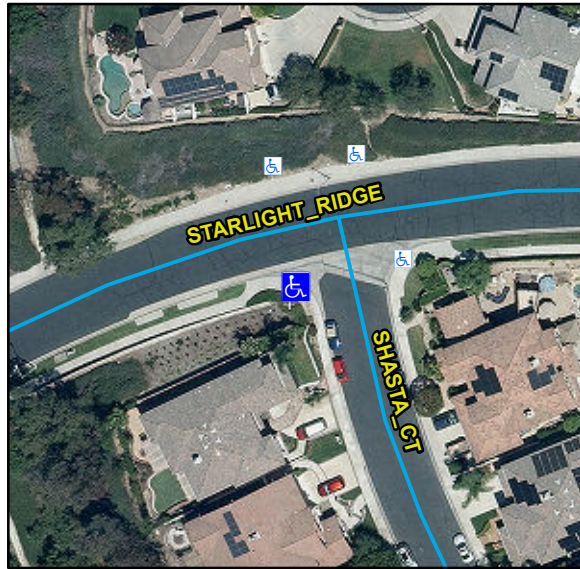
| Compliance | Description | Data | Compliance | Description | Data |
|---|---|---|---|---|---|
| Yes | Ramp Run Slope (%) | 2.1 | No | Flare Slope LT (%) | 18.3 |
| No | Ramp Cross Slope (%) | 11.8 | N/A | Flare Traversable LT | Yes |
| No | Landing Cross Slope (%) | N/A | No | DWS Provided | No |
| No | Gutter Lip Height (in) | 0.25 | | Road Run Slope (%) | 8.9 |
| No | Gutter Run Slope (%) | 5.1 | | Road Cross Slope (%) | 3.5 |
| No | Gutter Cross Slope (%) | 9.7 | | | |

Remove & Replace Curb Ramp With Two New Directional Ramps or Equivalent. Remove & Replace Gutter.
