# Access Compliance Report Public Rights-of-Way (Curb Ramps)

Main Street: STARLIGHT\_RIDGE Cross Street: SHASTA\_CT Location: SE

ADA ID: RPRK211018174509 Ramp Type: Type 1 - Perpendicular Diagonal Initial Pass/Fail: Fail Overall Compliance: No Severity Score: 30

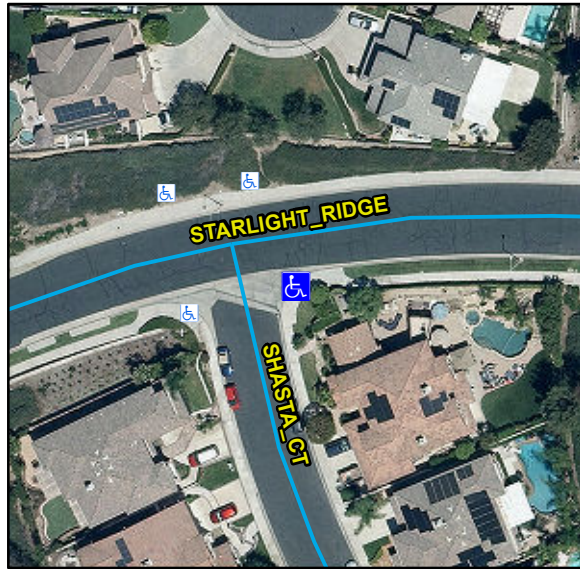
| Compliance | Description | Data | Compliance | Description | Data |
|---|---|---|---|---|---|
| No | Ramp Cross Slope (%) | 11.3 | N/A | Flare Traversable LT | N/A |
| No | Gutter Lip Height (in) | 0.5 | | Road Run Slope (%) | 6.2 |

Remove & Replace Curb Ramp With Two New Directional Ramps or Equivalent.

R304.2.2, R304.5.3, R302.7.2, STD 1115
