# Access Compliance Report Public Rights-of-Way (Curb Ramps)

Main Street: CHAPARRAL\_CT Cross Street: STARLIGHT\_RIDGE Location: SW

ADA ID: RPRK211018174758 Ramp Type: Type 4 - Parallel Initial Pass/Fail: Fail Overall Compliance: No Severity Score: 32

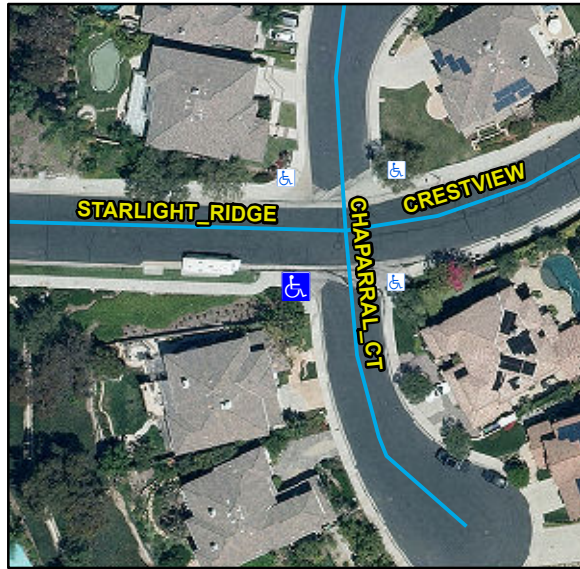
| Compliance | Description | Data | Compliance | Description | Data |
|---|---|---|---|---|---|
| No | Ramp Run Slope LT (%) | 19.3 | Yes | Ramp Run Slope RT (%) | 1.1 |
| No | Ramp Cross Slope LT (%) | 4.7 | Yes | Ramp Cross Slope RT (%) | 1.2 |

**Remove & Replace Curb Ramp With Two New Directional Ramps or Equivalent.**

**R304.3.2, R304.5.3, STD 1115**
