Main Street: CRESTVIEW Cross Street: CHAPARRAL\_CT Location: SE

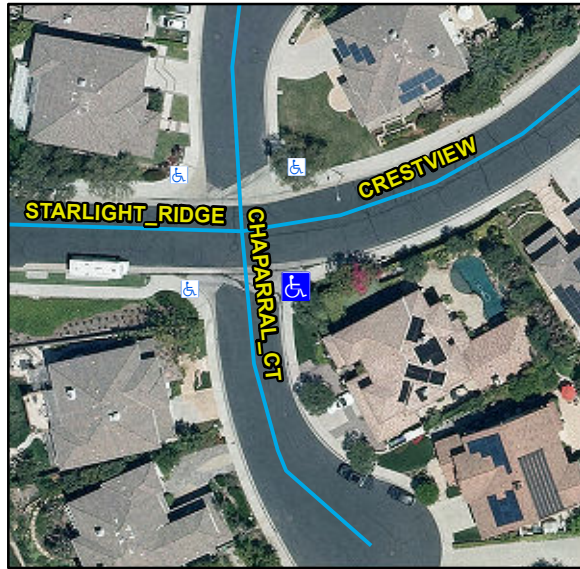
| Compliance | Description | Data | Compliance | Description | Data |
|---|---|---|---|---|---|
| Yes | Ramp Run Slope (%) | 2.9 | No | Flare Slope LT (%) | 12.1 |
| No | Ramp Cross Slope (%) | 6 | N/A | Flare Traversable LT | Yes |
| Yes | Gutter Ponding | No | No | Curb Slope | 9.4 |
| No | Gutter Lip Height (in) | 0.25 | | Road Run Slope (%) | 3 |
| No | Gutter Run Slope (%) | 5.3 | | Road Cross Slope (%) | 8.4 |
| No | Gutter Cross Slope (%) | 3.3 | | | |

### Possible Solutions:
