# Access Compliance Report Public Rights-of-Way (Curb Ramps)

Main Street: STARLIGHT\_RIDGE Cross Street: CHAPARRAL\_CT Location: NW

ADA ID: RPRK211018175219 Ramp Type: Type 4 - Parallel Initial Pass/Fail: Fail Overall Compliance: No Severity Score: 32

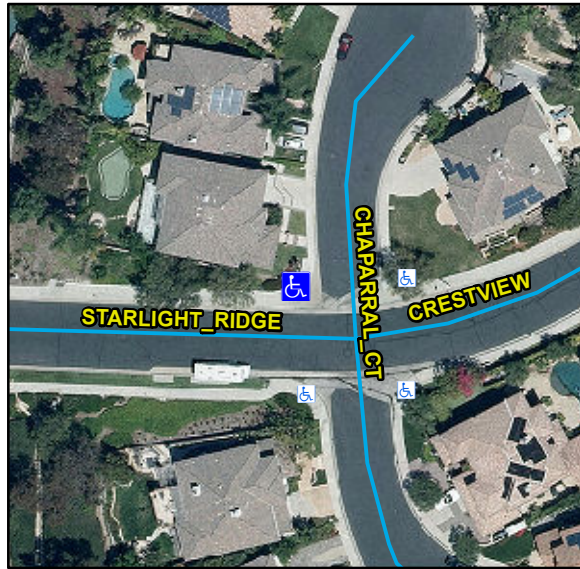
| Compliance | Description | Data | Compliance | Description | Data |
|---|---|---|---|---|---|
| Yes | Ramp Run Slope LT (%) | 5.2 | No | Ramp Run Slope RT (%) | 14.6 |
| No | Ramp Cross Slope LT (%) | 2.1 | Yes | Ramp Cross Slope RT (%) | 1 |
| No | Gutter Lip Height (in) | 0.25 | | Road Run Slope (%) | 10.4 |

Remove & Replace Curb Ramp With Two New Directional Ramps or Equivalent. Grind Gutter Lip.

R304.5.3, R304.3.2, R302.7.2, STD 1115
