Access Compliance Report Public Rights-of-Way (Curb Ramps)

Main Street: CHAPARRAL_CT **Cross Street:** CRESTVIEW **Location:** NE

ADA ID: RPRK211018175449 **Ramp Type:** Type 1 - Perpendicular Diagonal Initial Pass/Fail: Fail **Overall Compliance:** No **Severity Score:** 2

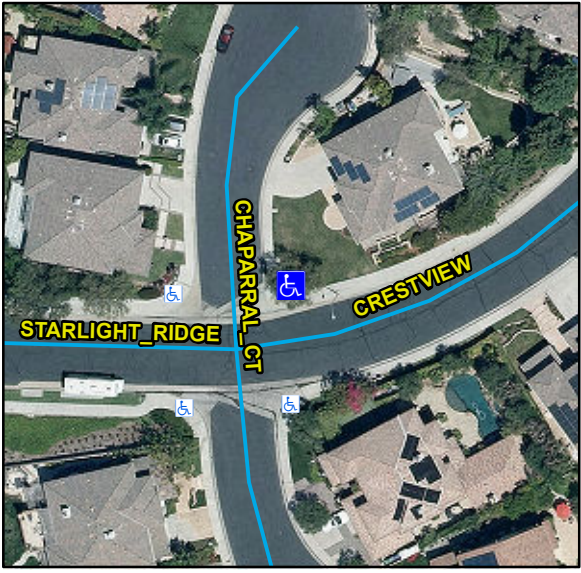
OC Std/PROW:
 R304.2.2, R304.5.3, R302.7.2, STD 1115

Compliance	Description	Data	Compliance	Description	Data
N/A	Ramp Length (in)	85	N/A	Flare Type LT	
Yes	Ramp Width (in)	48			N/A
Yes	Ramp Run Slope (%)	3.4	N/A	Flare Slope LT (%)	N/A
No	Ramp Cross Slope (%)	4.9	N/A	Flare Traversable LT	N/A
N/A	Landing Present	N/A	N/A	Flare Type RT	
N/A	Landing Length (in)	N/A			N/A
N/A	Landing Width (in)	N/A	N/A	Flare Slope RT (%)	N/A
N/A	Landing Run Slope (%)	N/A	N/A	Flare Traversable RT	N/A
N/A	Landing Cross Slope (%)	N/A	N/A	DWS Provided	N/A
N/A	Landing Movement Obstructed?	N/A	N/A	DWS Contrast	N/A
	Landing Movement Type	N/A	N/A	DWS Length (in)	N/A
N/A	Landing Shared	N/A	N/A	DWS Full Width	N/A
N/A	Clear Space	Yes	N/A	DWS Offset Left (in)	N/A
N/A	Clear Space To Crosswalk (in)	N/A	N/A	DWS Offset Right (in)	N/A
N/A	Marked Crosswalk 1	No	N/A	Marked Crosswalk 2	No
	Crossing 1 Direction	W		Crossing 2 Direction	S
	Marked Crosswalk 1 Width (in)	N/A		Marked Crosswalk 2 Width (in)	N/A

N/A	Ramp Inside Crosswalk 1	N/A	Yes	Ramp Inside Crosswalk 2	N/A
	Crossing 1 Slope (%)	3.7		Crossing 2 Slope (%)	2.7
	Crossing 1 Cross Slope (%)	2.8		Crossing 2 Cross Slope (%)	6.6
N/A	Gutter Ponding	N/A	No	Curb Slope	5.9
No	Gutter Lip Height (in)	0.25		Road Run Slope (%)	4.5
N/A	Gutter Run Slope (%)	N/A		Road Cross Slope (%)	5
N/A	Gutter Cross Slope (%)	N/A			
Yes	Overall Surface Condition:	Acceptable	Yes	Perp Joint Present	Yes
	Cross Gutter Present?	Yes		Spandrel Present?	Yes
	Replace Cross Gutter?	No		Replace Spandrel?	No

Possible Solutions:
Remove & Replace Curb Ramp With Two New Directional Ramps or Equivalent.
