# Access Compliance Report Public Rights-of-Way (Curb Ramps)

Main Street: HILLSIDE\_DR Cross Street: CRESTVIEW Location: NW

ADA ID: RPRK211018175935 Ramp Type: Type 4 - Parallel Initial Pass/Fail: Fail Overall Compliance: No Severity Score: 34

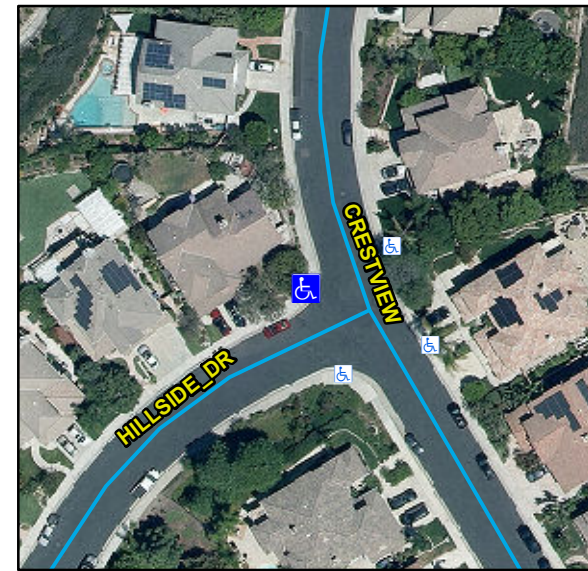
| Compliance | Description | Data | Compliance | Description | Data |
|---|---|---|---|---|---|
| No | Ramp Width LT (in) | 42 | No | Ramp Width RT (in) | 44 |
| No | Ramp Run Slope LT (%) | 9.7 | Yes | Ramp Run Slope RT (%) | 2.5 |
| No | Ramp Cross Slope LT (%) | 4.5 | No | Ramp Cross Slope RT (%) | 6.9 |
| No | Gutter Lip Height (in) | 1.1 | | Road Run Slope (%) | 4.3 |

**Remove & Replace Curb Ramp With Two New Directional Ramps or Equivalent. Grind Gutter Lip.**

**R204.3, R304.5.1, R304.3.2, R304.5.3, R302.7.2, STD 1115**
