# Access Compliance Report Public Rights-of-Way (Curb Ramps)

Main Street: CRESTVIEW Cross Street: HILLSIDE\_DR Location: SW

ADA ID: RPRK211018180247 Ramp Type: Type 4 - Parallel Initial Pass/Fail: Fail Overall Compliance: No Severity Score: 34

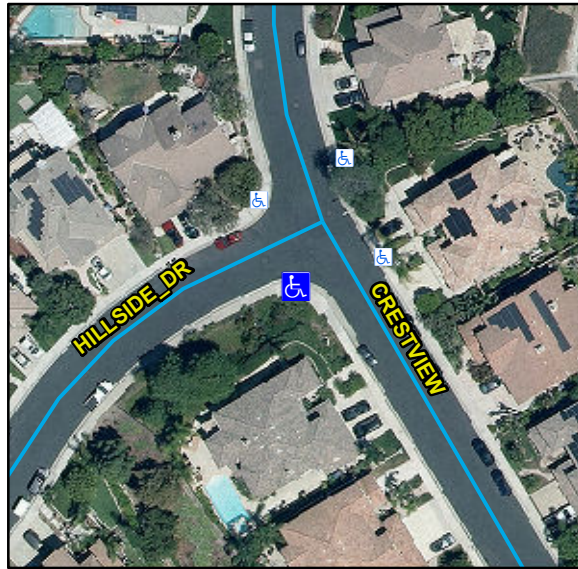
| Compliance | Description | Data | Compliance | Description | Data |
|---|---|---|---|---|---|
| No | Ramp Width LT (in) | 42 | No | Ramp Width RT (in) | 42 |
| No | Ramp Cross Slope LT (%) | 14.9 | No | Ramp Cross Slope RT (%) | 10.6 |
| No | Gutter Lip Height (in) | 0.25 | | Road Run Slope (%) | 7.7 |

**Remove & Replace Curb Ramp With Two New Directional Ramps or Equivalent. Grind Gutter Lip.**

**R204.3, R304.5.1, R304.5.3, R302.7.2, STD 1115**
