# Access Compliance Report Public Rights-of-Way (Curb Ramps)

| Main Street: MEANDERING_TRAIL | | Cross Street: STARLIGHT_RIDGE | | Location: | SW |
| ADA ID: RPRK211018181126 | Ramp Type:Type 1 - Perpendicular | Initial Pass/Fail: Fail | Overall Compliance: No | Severity Score: | 16 |

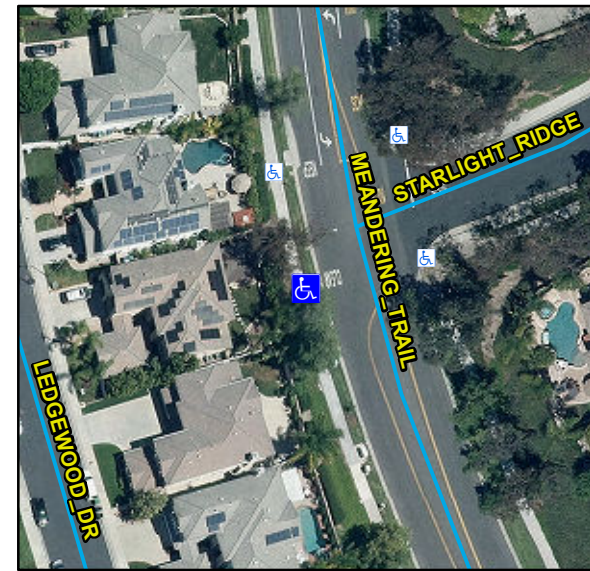
| Compliance | Description | Data | Compliance | Description | Data |
|---|---|---|---|---|---|
| No | Ramp Run Slope (%) | 10.3 | N/A | Flare Slope LT (%) | N/A |
| N/A | Gutter Ponding | N/A | No | Curb Slope | 9.3 |

Remove & Replace Entire Ramp.

R304.2.2, R204.3, STD 1115

Total Cost: \$ 3080
