# Access Compliance Report Public Rights-of-Way (Curb Ramps)

Main Street: STARLIGHT\_RIDGE Cross Street: MEANDERING\_TRAIL Location: SE

ADA ID: RPRK211018181311 Ramp Type: Type 1 - Perpendicular Diagonal Initial Pass/Fail: Fail Overall Compliance: No Severity Score: 2

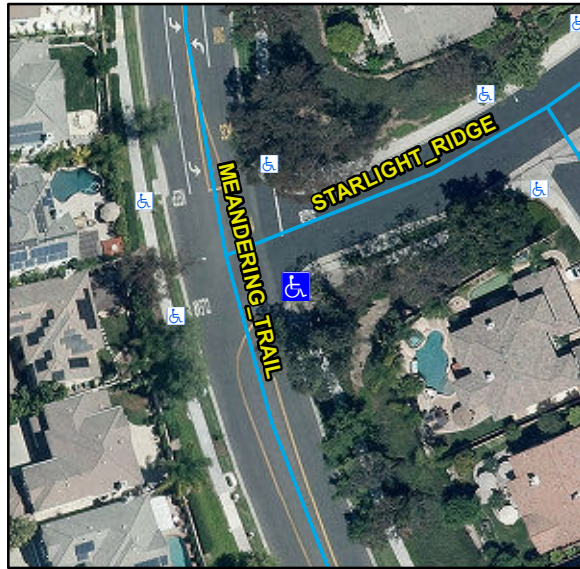
R304.2.2, R204.3, R304.5.3, STD 1115

| Compliance | Description | Data | Compliance | Description | Data |
|---|---|---|---|---|---|
| No | Ramp Cross Slope (%) | 3.3 | N/A | Flare Traversable LT | N/A |

Remove & Replace Curb Ramp With Two New Directional Ramps or Equivalent.
