# Access Compliance Report Public Rights-of-Way (Curb Ramps)

| Main Street: ANTONIO_PKWY | | Cross Street: OAKTREE | | Location: | SE |

| ADA ID: RPRK211019113532 | Ramp Type: Type 4 - Parallel | Initial Pass/Fail: Fail | Overall Compliance: No | Severity Score: | 30 |

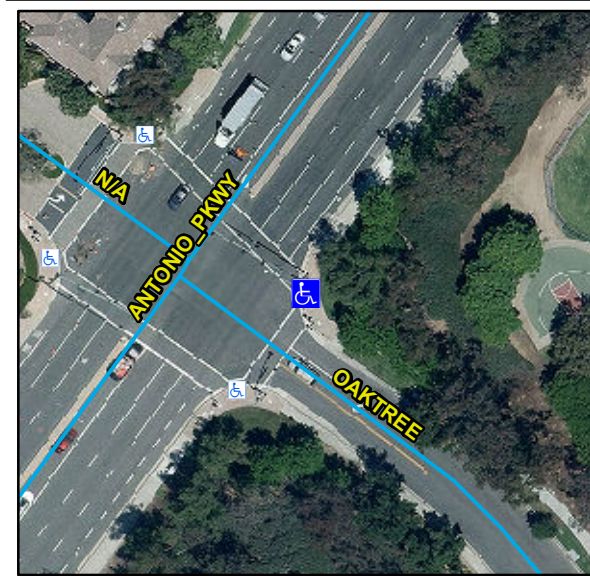
| Compliance | Description | Data | Compliance | Description | Data |
|---|---|---|---|---|---|
| No | Ramp Cross Slope LT (%) | 7.4 | No | Ramp Cross Slope RT (%) | 8.9 |
| N/A | Gutter Ponding | N/A | No | Curb Slope | 10.4 |
| No | Gutter Lip Height (in) | 0.25 | | Road Run Slope (%) | 0.2 |

**Remove & Replace Curb Ramp With Two New Directional Ramps or Equivalent.**

**R304.2.2, R204.3, R304.5.3, R302.7.2, STD 1115**

Total Cost: \$ 4000
