# Access Compliance Report Public Rights-of-Way (Curb Ramps)

| Main Street: OAKTREE | | Cross Street: ANTONIO_PKWY | | Location: | SW |
| ADA ID: RPRK211019114044 | Ramp Type: Type 4 - Parallel | Initial Pass/Fail: Fail | Overall Compliance: No | Severity Score: | 30 |

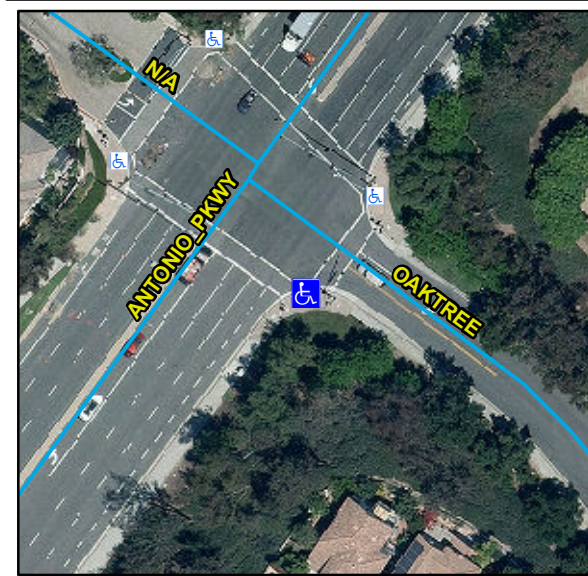
| Compliance | Description | Data | Compliance | Description | Data |
|---|---|---|---|---|---|
| No | Ramp Cross Slope LT (%) | 8.2 | No | Ramp Cross Slope RT (%) | 9.9 |
| No | Gutter Lip Height (in) | 0.5 | | Road Run Slope (%) | 3.2 |

**Remove & Replace Curb Ramp With Two New Directional Ramps or Equivalent. Grind Gutter Lip.**

**R204.3, R304.5.3, R302.7.2, STD 1115**

Total Cost: \$ 4150

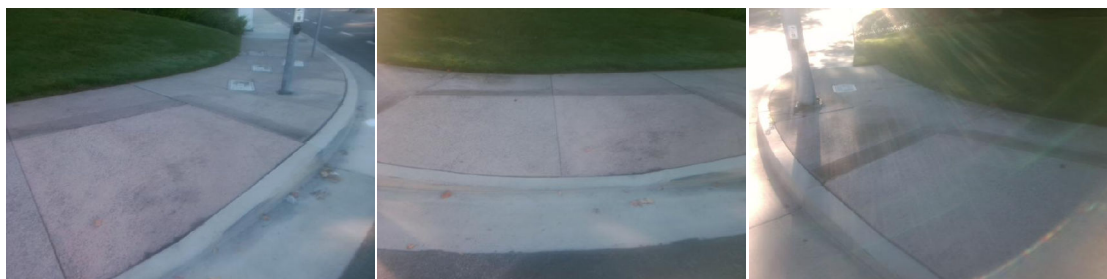
| Compliance | Description | Data | Compliance | Description | Data |
|---|---|---|---|---|---|
| Yes | Overall Surface Condition | Acceptable | | | |
| | Cross Gutter Present? | No | | Spandrel Present? | No |
| | Replace Cross Gutter? | N/A | | Replace Spandrel? | N/A |
