# Access Compliance Report Public Rights-of-Way (Curb Ramps)

Main Street: SWEETWATER Cross Street: ANTONIO\_PKWY Location: S

ADA ID: RPRK211019115526 Ramp Type: Type 4 - Parallel Initial Pass/Fail: Fail Overall Compliance: No Severity Score: 30

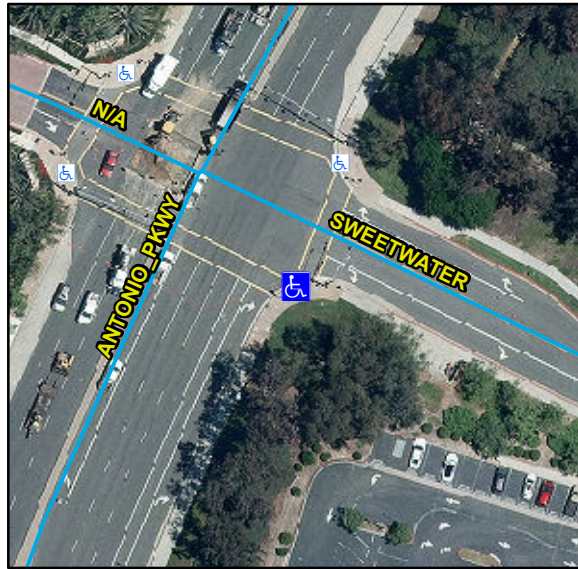
| Compliance | Description | Data | Compliance | Description | Data |
|---|---|---|---|---|---|
| No | Ramp Cross Slope LT (%) | 9.9 | No | Ramp Cross Slope RT (%) | 10.2 |
| No | Gutter Lip Height (in) | 0.25 | | Road Run Slope (%) | 4.6 |

Remove & Replace Curb Ramp With Two New Directional Ramps or Equivalent. Grind Gutter Lip.

R204.3, R304.5.3, R302.7.2, STD 1115
