# Access Compliance Report Public Rights-of-Way (Curb Ramps)

| Main Street: ANTONIO_PKWY | | Cross Street: SWEETWATER | | Location: | E |
| ADA ID: RPRK211019120133 | Ramp Type: Type 4 - Parallel | Initial Pass/Fail: Fail | Overall Compliance: No | Severity Score: | 45 |

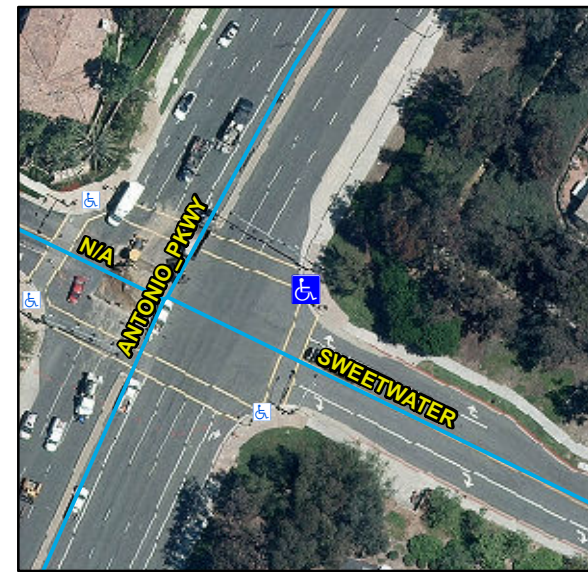
| Compliance | Description | Data | Compliance | Description | Data |
|---|---|---|---|---|---|
| Yes | Ramp Run Slope LT (%) | 4.3 | No | Ramp Run Slope RT (%) | 10.6 |
| No | Ramp Cross Slope LT (%) | 6.7 | No | Ramp Cross Slope RT (%) | 7.1 |
| No | Gutter Lip Height (in) | 0.25 | | Road Run Slope (%) | 0.8 |

**Remove & Replace Curb Ramp With Two New Directional Ramps or Equivalent. Grind Gutter Lip.**

**R204.3, R304.5.3, R304.3.2, R302.7.2, STD 1115**
