# Access Compliance Report Public Rights-of-Way (Curb Ramps)

Main Street: ANTONIO\_PKWY Cross Street: OSO\_PKWY Location: E

ADA ID: RPRK211019123352 Ramp Type: Type 1 - Perpendicular Diagonal Initial Pass/Fail: Fail Overall Compliance: No Severity Score: 16

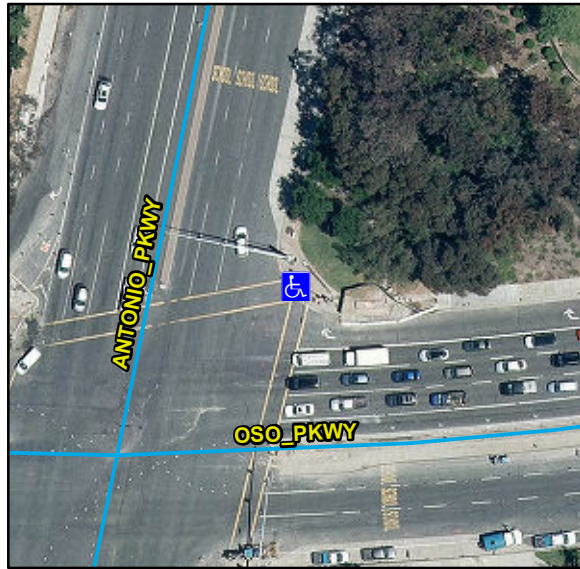
| Compliance | Description | Data | Compliance | Description | Data |
|---|---|---|---|---|---|
| No | Ramp Run Slope (%) | 8.4 | N/A | Flare Slope LT (%) | N/A |

Remove & Replace Curb Ramp With Two New Directional Ramps or Equivalent.

R304.2.2, STD 1115
