# Access Compliance Report Public Rights-of-Way (Curb Ramps)

Main Street: **OSO\_PKWY** Cross Street: **ANTONIO\_PKWY** Location: **S**

ADA ID: **RPRK211019123845** Ramp Type: **Type 1 - Perpendicular Diagonal Initial Pass/Fail: Pass** Overall Compliance: **No** Severity Score: **4**

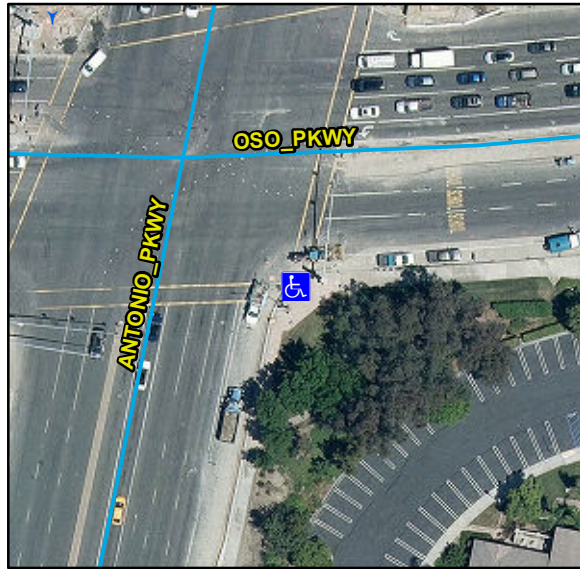
| Compliance | Description | Data | Compliance | Description | Data |
|---|---|---|---|---|---|
| <b>N/A</b> | Landing Length (in) | <b>37</b> | | | <b>Sloped</b> |

Possible Solutions:

**Remove & Replace Landing.**

**R304.2.1, STD 1115**
