# Access Compliance Report Public Rights-of-Way (Curb Ramps)

Main Street: **SUNNY\_SLOPE** Cross Street: **SUNNY\_SLOPE** Location: **W**

ADA ID: **RPRK211019130033** Ramp Type: **Type 4 - Parallel** Initial Pass/Fail: **Fail** Overall Compliance: **No** Severity Score: **15**

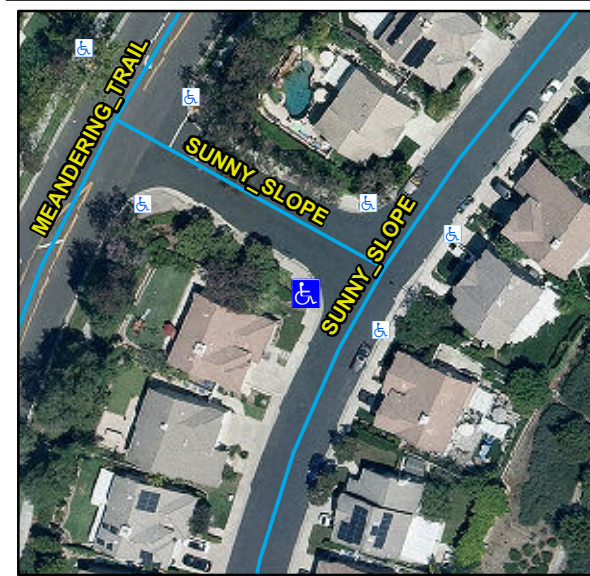
| Compliance | Description | Data | Compliance | Description | Data |
|---|---|---|---|---|---|
| <b>No</b> | Ramp Run Slope LT (%) | <b>9.2</b> | <b>Yes</b> | Ramp Run Slope RT (%) | <b>2.1</b> |

Possible Solutions:  
**Remove & Replace Curb Ramp With Two New Directional Ramps or Equivalent.**

OC Std/PROW:  
**R304.3.2, STD 1115**
