# Access Compliance Report Public Rights-of-Way (Curb Ramps)

Main Street: MEANDERING\_TRAIL Cross Street: SUNNY\_SLOPE Location: E

ADA ID: RPRK211019130758 Ramp Type: Type 4 - Parallel Initial Pass/Fail: Fail Overall Compliance: No Severity Score: 30

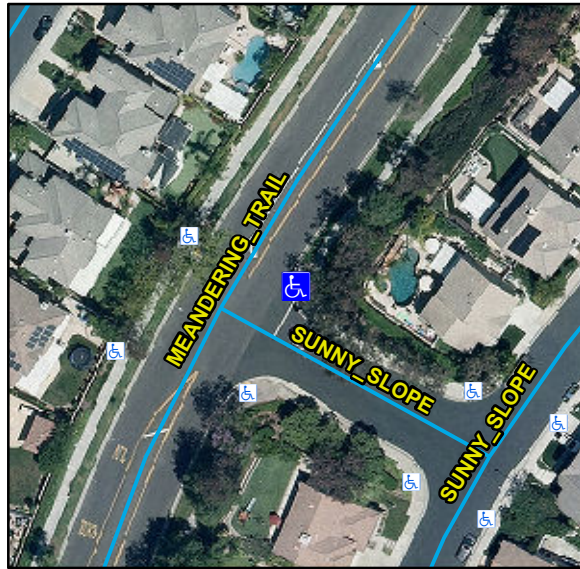
| Compliance | Description | Data | Compliance | Description | Data |
|---|---|---|---|---|---|
| Yes | Ramp Run Slope LT (%) | 3.8 | No | Ramp Run Slope RT (%) | 9.7 |
| No | Ramp Cross Slope LT (%) | 6.7 | No | Ramp Cross Slope RT (%) | 6.2 |

Remove & Replace Curb Ramp With Two New Directional Ramps or Equivalent.

R204.3, R304.5.3, R304.3.2, STD 1115

Total Cost: \$ 4000
