# Access Compliance Report Public Rights-of-Way (Curb Ramps)

| Main Street: <b>SUNNY_SLOPE</b> | | Cross Street: <b>MEANDERING_TRAIL</b> | | Location: <b>S</b> |
| ADA ID: <b>RPRK211019131050</b> | Ramp Type: <b>Type 4 - Parallel</b> | Initial Pass/Fail: <b>Fail</b> | Overall Compliance: <b>No</b> | Severity Score: <b>30</b> |

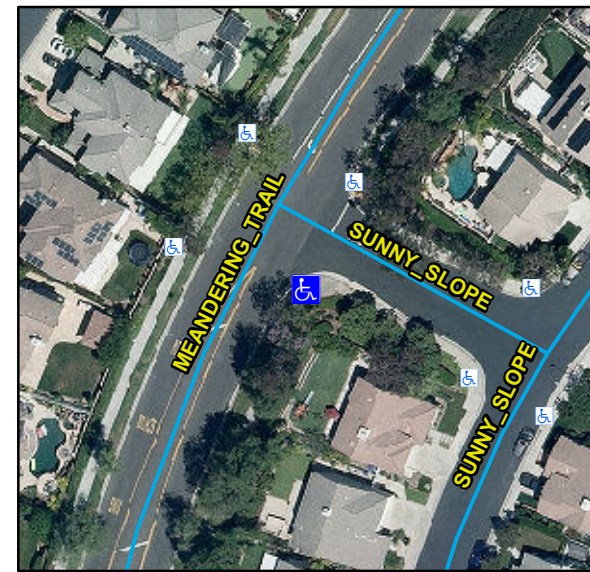
| Compliance | Description | Data | Compliance | Description | Data |
|---|---|---|---|---|---|
| <b>No</b> | Ramp Cross Slope LT (%) | <b>7.9</b> | <b>No</b> | Ramp Cross Slope RT (%) | <b>8.2</b> |

**Remove & Replace Curb Ramp With Two New Directional Ramps or Equivalent.**

**R204.3, R304.5.3, STD 1115**

Total Cost: \$ **4000**
