# Access Compliance Report Public Rights-of-Way (Curb Ramps)

| Main Street: MEANDERING_TRAIL | | Cross Street: SUNNY_SLOPE | | Location: | N |
| ADA ID: RPRK211019131337 | Ramp Type:Type 1 - Perpendicular | Initial Pass/Fail: Fail | Overall Compliance: No | Severity Score: | 15 |

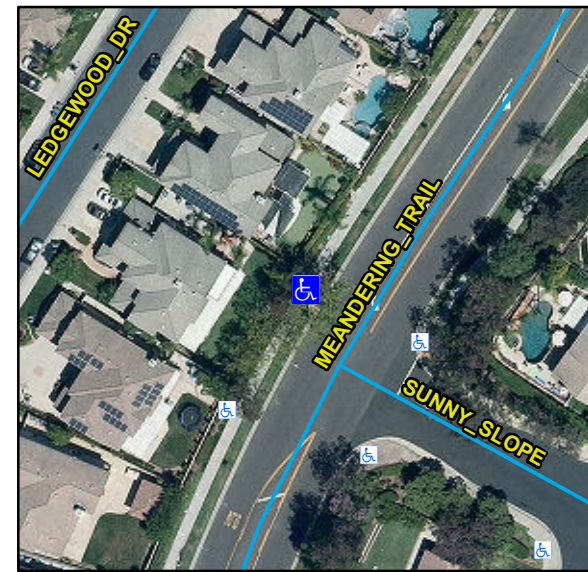
| Compliance | Description | Data | Compliance | Description | Data |
|---|---|---|---|---|---|
| No | Ramp Run Slope (%) | 8.4 | N/A | Flare Slope LT (%) | N/A |

Remove & Replace Entire Ramp.
