# Access Compliance Report Public Rights-of-Way (Curb Ramps)

Main Street: GRASSY\_KNOLL\_LN Cross Street: MEANDERING\_TRAIL Location: NW

ADA ID: RPRK211019131615 Ramp Type: Type 4 - Parallel Initial Pass/Fail: Fail Overall Compliance: No Severity Score: 15

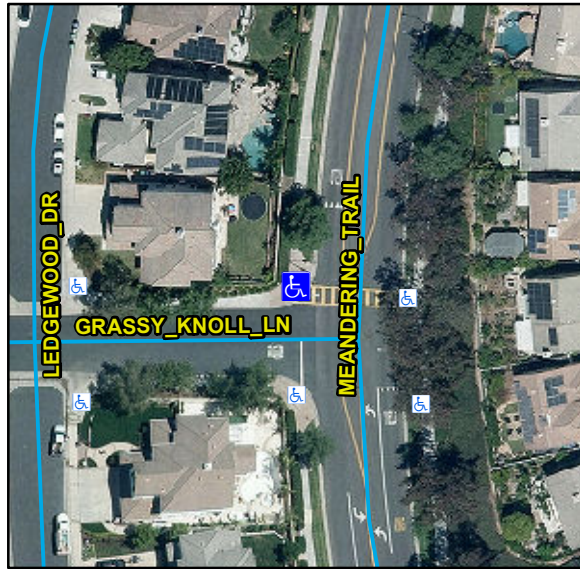
| Compliance | Description | Data | Compliance | Description | Data |
|---|---|---|---|---|---|
| No | Ramp Cross Slope LT (%) | 5.4 | No | Ramp Cross Slope RT (%) | 4.5 |

**Remove & Replace Curb Ramp With Two New Directional Ramps or Equivalent.**

**R204.3, R304.5.3, STD 1115**
