# Access Compliance Report Public Rights-of-Way (Curb Ramps)

| Main Street: MEANDERING_TRAIL | | Cross Street: GRASSY_KNOLL_LN | | Location: | SW |
| ADA ID: RPRK211019132052 | Ramp Type: Type 4 - Parallel | Initial Pass/Fail: Fail | Overall Compliance: No | Severity Score: | 15 |

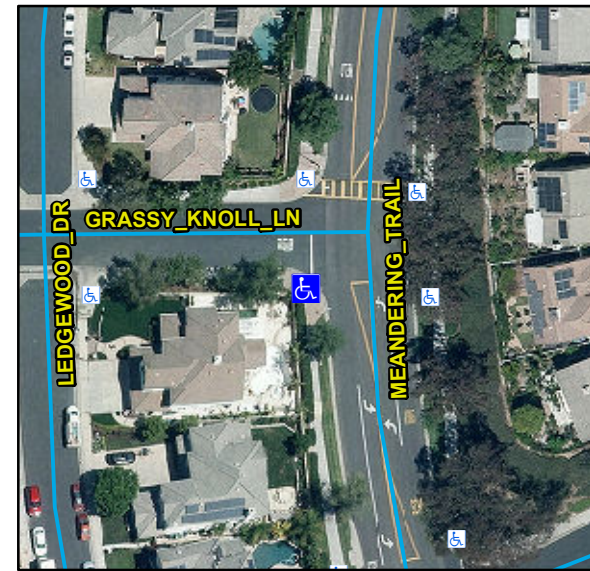
| Compliance | Description | Data | Compliance | Description | Data |
|---|---|---|---|---|---|
| No | Ramp Cross Slope LT (%) | 5.4 | No | Ramp Cross Slope RT (%) | 4.6 |

**Remove & Replace Curb Ramp With Two New Directional Ramps or Equivalent.**

**R204.3, R304.5.3, STD 1115**

Total Cost: \$ 4000
