# Access Compliance Report Public Rights-of-Way (Curb Ramps)

Main Street: MEANDERING\_TRAIL Cross Street: GRASSY\_KNOLL\_LN Location: E

ADA ID: RPRK211019132503 Ramp Type: Type 4 - Parallel Initial Pass/Fail: Fail Overall Compliance: No Severity Score: 32

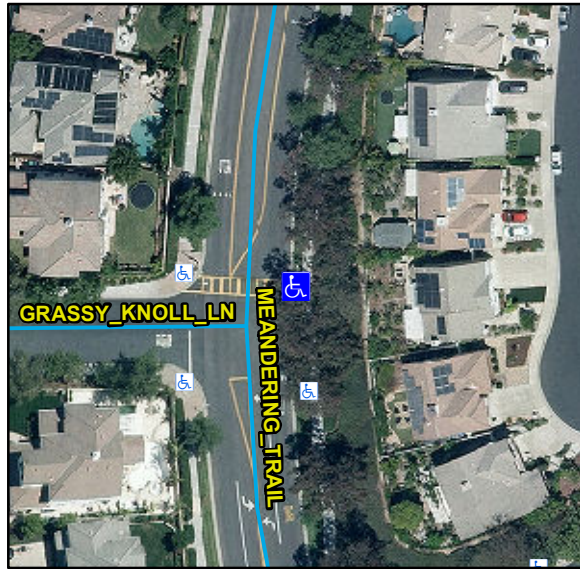
| Compliance | Description | Data | Compliance | Description | Data |
|---|---|---|---|---|---|
| No | Ramp Run Slope LT (%) | 12.5 | Yes | Ramp Run Slope RT (%) | 4.9 |
| No | Ramp Cross Slope LT (%) | 4.5 | No | Ramp Cross Slope RT (%) | 4.1 |

Remove & Replace Entire Ramp.

R204.3, R304.3.2, R304.5.3, STD 1115
