# Access Compliance Report Public Rights-of-Way (Curb Ramps)

| Main Street: SUNNYDALE_LN | | Cross Street: GRASSY_KNOLL_LN | | Location: | SW |
| ADA ID: RPRK211019133010 | Ramp Type: Type 4 - Parallel | Initial Pass/Fail: Fail | Overall Compliance: No | Severity Score: | 45 |

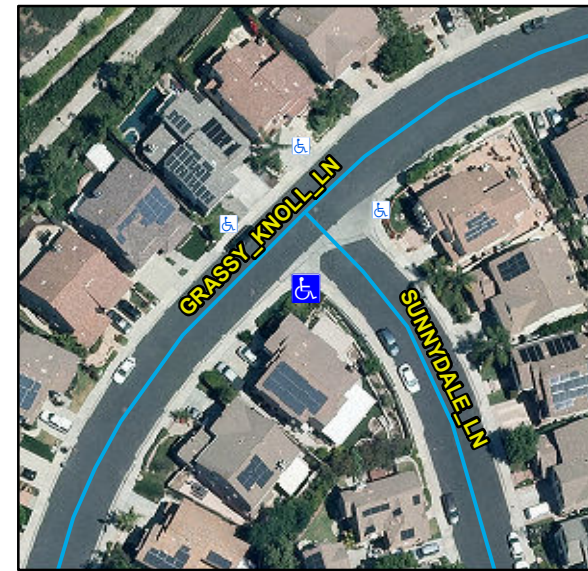
| Compliance | Description | Data | Compliance | Description | Data |
|---|---|---|---|---|---|
| No | Ramp Run Slope LT (%) | 11.4 | Yes | Ramp Run Slope RT (%) | 5.8 |
| No | Ramp Cross Slope LT (%) | 10.3 | No | Ramp Cross Slope RT (%) | 8.8 |
| No | Gutter Lip Height (in) | 0.25 | | Road Run Slope (%) | 6 |

**Remove & Replace Curb Ramp With Two New Directional Ramps or Equivalent. Grind Gutter Lip.**

**R204.3, R304.3.2, R304.5.3, R302.7.2, STD 1115**

Total Cost: \$ 4150

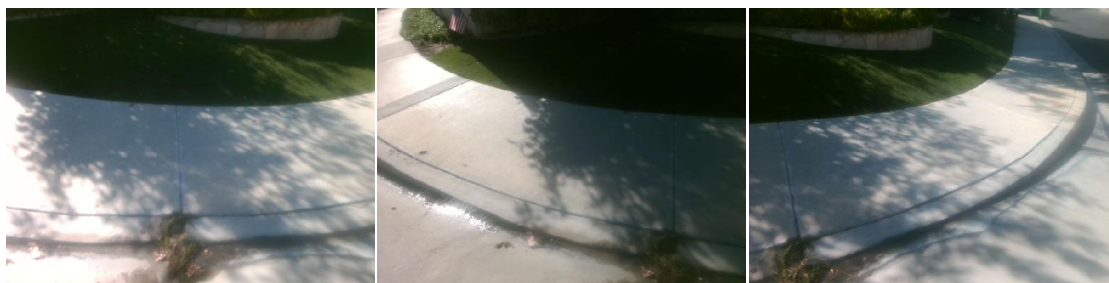
| Compliance | Description | Data | Compliance | Description | Data |
|---|---|---|---|---|---|
| N/A | Ramp Length LT (in) | 115 | N/A | Ramp Length RT (in) | 110 |
| Yes | Ramp Width LT (in) | 53 | Yes | Ramp Width RT (in) | 54 |
| | Crossing 1 Slope (%) | 8 | | Crossing 2 Slope (%) | 1.5 |
| | Crossing 1 Cross Slope (%) | 5.5 | | Crossing 2 Cross Slope (%) | 5.3 |
| N/A | Gutter Ponding | N/A | N/A | Curb Slope | 10.5 |
