# Access Compliance Report Public Rights-of-Way (Curb Ramps)

Main Street: GRASSY\_KNOLL\_LN Cross Street: SUNNYDALE\_LN Location: SE

ADA ID: RPRK211019133255 Ramp Type: Type 4 - Parallel Initial Pass/Fail: Fail Overall Compliance: No Severity Score: 30

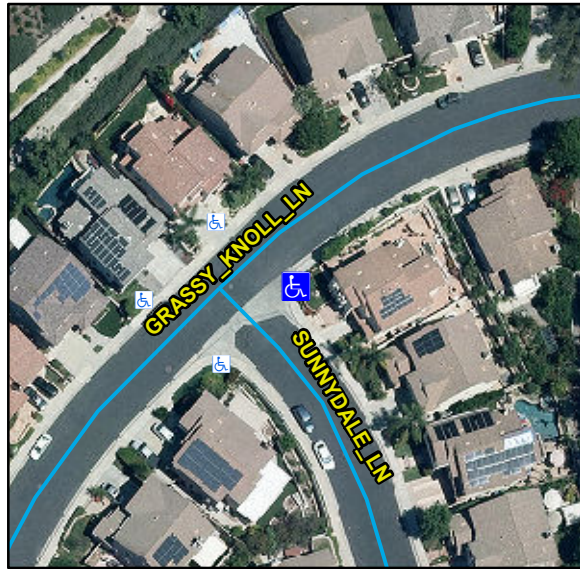
| Compliance | Description | Data | Compliance | Description | Data |
|---|---|---|---|---|---|
| No | Ramp Cross Slope LT (%) | 7.9 | No | Ramp Cross Slope RT (%) | 8 |
| No | Gutter Lip Height (in) | 0.25 | | Road Run Slope (%) | 2.4 |

**Remove & Replace Curb Ramp With Two New Directional Ramps or Equivalent. Grind Gutter Lip.**
