# Access Compliance Report Public Rights-of-Way (Curb Ramps)

Main Street: LEDGEWOOD\_DR Cross Street: GRASSY\_KNOLL\_LN Location: SW

ADA ID: RPRK211019133600 Ramp Type: Type 4 - Parallel Initial Pass/Fail: Fail Overall Compliance: No Severity Score: 34

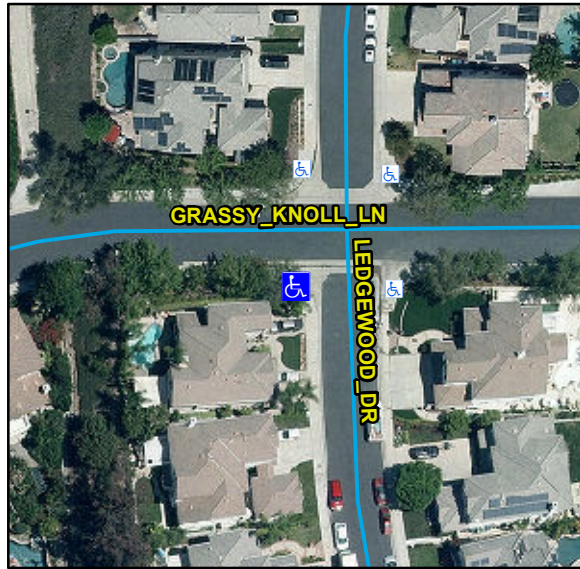
| Compliance | Description | Data | Compliance | Description | Data |
|---|---|---|---|---|---|
| No | Ramp Width LT (in) | 41 | No | Ramp Width RT (in) | 42 |
| No | Ramp Cross Slope LT (%) | 10.7 | No | Ramp Cross Slope RT (%) | 9.2 |
| N/A | Gutter Cross Slope (%) | N/A | No | Perpendicular Joint Present | No |

**Remove & Replace Curb Ramp With Two New Directional Ramps or Equivalent.**

**R204.3, R304.5.1, R304.5.3, STD 1115**

Total Cost: \$ 4000
