# Access Compliance Report Public Rights-of-Way (Curb Ramps)

| Main Street: GRASSY_KNOLL_LN | | Cross Street: LEDGEWOOD_DR | | Location: | NW |
| ADA ID: RPRK211019133933 | Ramp Type: Type 4 - Parallel | Initial Pass/Fail: Fail | Overall Compliance: No | Severity Score: | 49 |

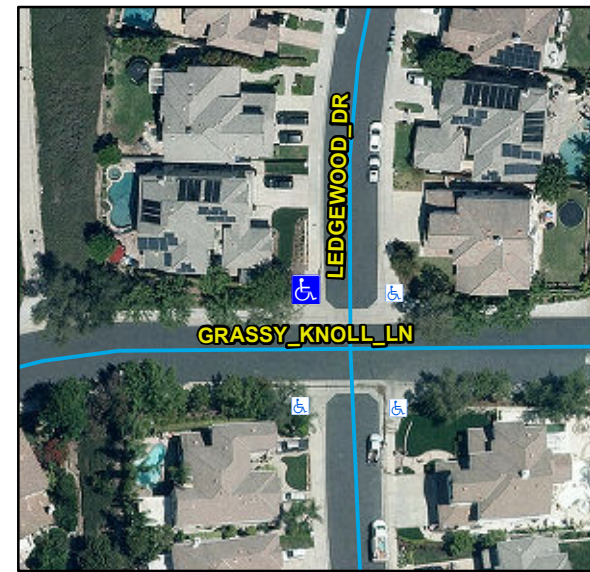
| Compliance | Description | Data | Compliance | Description | Data |
|---|---|---|---|---|---|
| N/A | Ramp Length LT (in) | 118 | N/A | Ramp Length RT (in) | 116 |
| No | Ramp Width LT (in) | 40 | No | Ramp Width RT (in) | 42 |
| Yes | Ramp Run Slope LT (%) | 1.3 | No | Ramp Run Slope RT (%) | 9.5 |
| No | Ramp Cross Slope LT (%) | 9.9 | No | Ramp Cross Slope RT (%) | 10.5 |

**Remove & Replace Curb Ramp With Two New Directional Ramps or Equivalent.**

**R204.3, R304.5.1, R304.5.3, R304.3.2, STD 1115**

Total Cost: \$ 4000
