# Access Compliance Report Public Rights-of-Way (Curb Ramps)

Main Street: LEDGEWOOD\_DR Cross Street: GRASSY\_KNOLL\_LN Location: NE

ADA ID: RPRK211019134156 Ramp Type: Type 4 - Parallel Initial Pass/Fail: Fail Overall Compliance: No Severity Score: 34

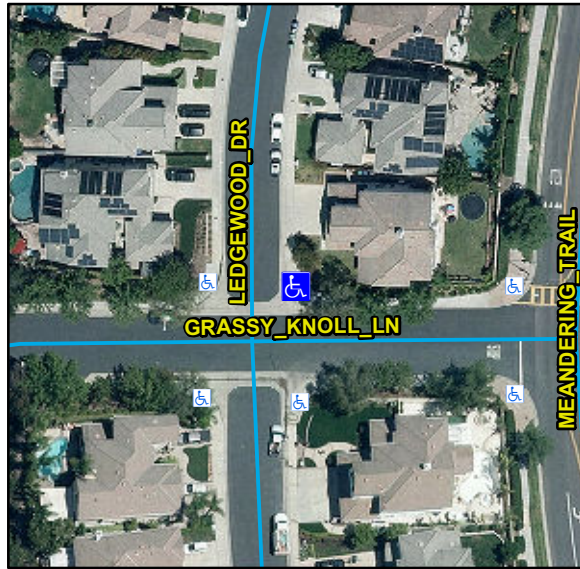
| Compliance | Description | Data | Compliance | Description | Data |
|---|---|---|---|---|---|
| No | Ramp Width LT (in) | 42 | No | Ramp Width RT (in) | 42 |
| No | Ramp Cross Slope LT (%) | 11.2 | No | Ramp Cross Slope RT (%) | 14.2 |

**Remove & Replace Curb Ramp With Two New Directional Ramps or Equivalent.**

**R204.3, R304.5.1, R304.5.3, STD 1115**

Total Cost: \$ 4000
