# Access Compliance Report Public Rights-of-Way (Curb Ramps)

Main Street: GRASSY\_KNOLL\_LN Cross Street: LEDGEWOOD\_DR Location: SE

ADA ID: RPRK211019134405 Ramp Type: Type 4 - Parallel Initial Pass/Fail: Fail Overall Compliance: No Severity Score: 49

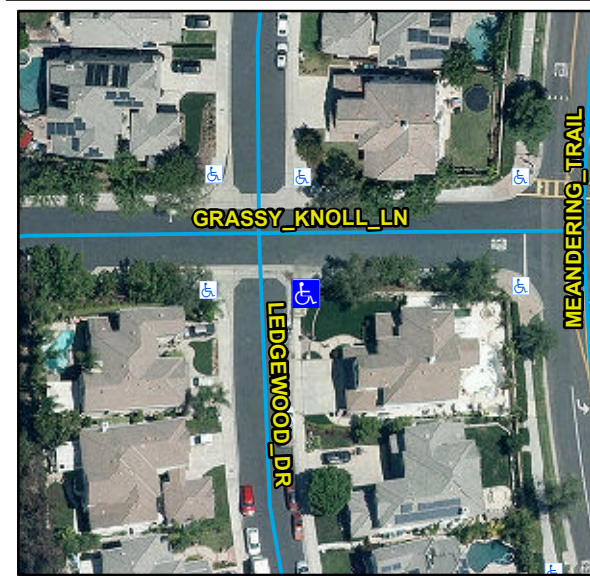
| Compliance | Description | Data | Compliance | Description | Data |
|---|---|---|---|---|---|
| No | Ramp Width LT (in) | 43 | No | Ramp Width RT (in) | 42 |
| No | Ramp Run Slope LT (%) | 12 | Yes | Ramp Run Slope RT (%) | 2.6 |
| No | Ramp Cross Slope LT (%) | 5.7 | No | Ramp Cross Slope RT (%) | 10.6 |

Possible Solutions:  
**Remove & Replace Curb Ramp With Two New Directional Ramps or Equivalent.**
